IMPORTANT SAFETY RECALL

GM Recall Number: 14187

DRIVER AND PASSENGER SAFETY BELT SLEEVE INSPECTION PROCEDURE

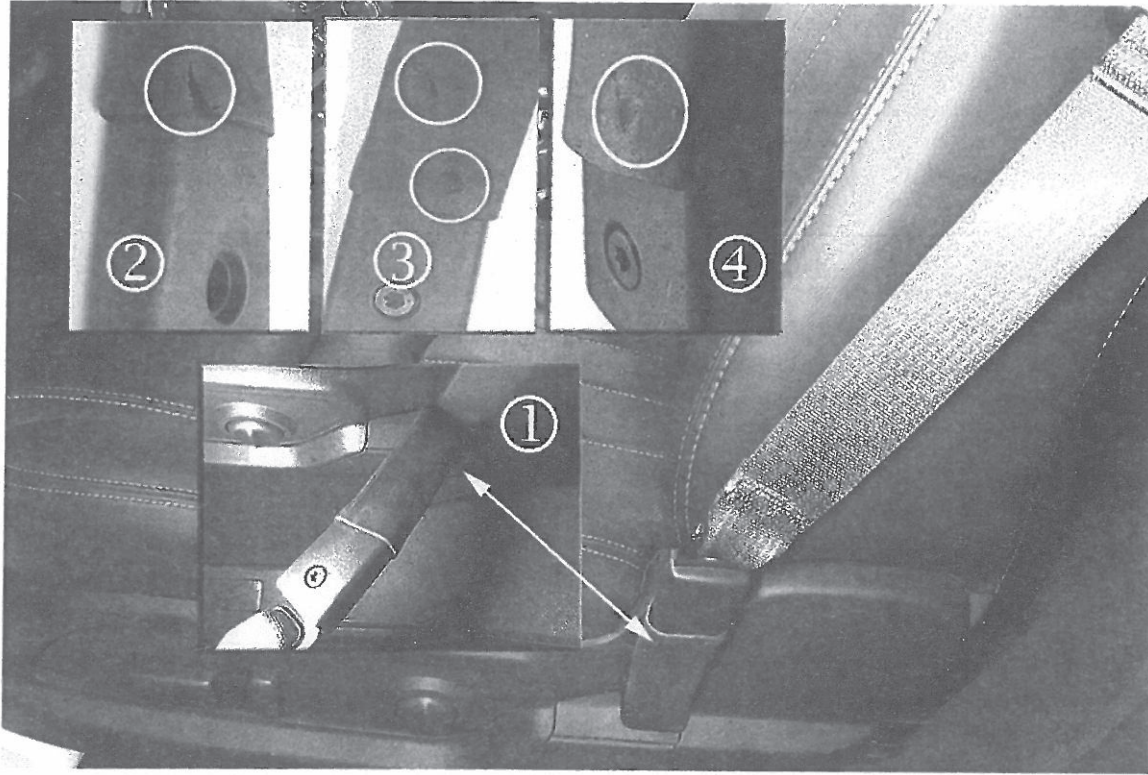
Note: With the vehicle door fully open, it will be necessary to pull the safety belt assembly downward until you are able to view the inboard side of the safety belt sleeve (1).

2. Inspect the safety belt sleeve for any tears (2), holes (3) or wear marks (4). This inspection must be performed on both the driver and passenger safety belt sleeve.
 - If the driver and passenger safety belt sleeves show no visible tears, holes or wear marks, no further action is required until you receive a second letter from GM asking you to take your vehicle to your dealer.
 - If either the driver or passenger safety belt sleeve shows a tear, hole or wear mark, please stop driving your vehicle and immediately contact your GM dealer. Your dealer will arrange for your vehicle to be towed to the dealership at no charge and provide you with a free loaner vehicle until this condition can be corrected on your vehicle.

1. Move the front seats to the full forward and full downward position. The safety belt sleeve covers the flexible steel cable that connects the safety belt to the vehicle's floor pan at the outside of the front outboard seating positions.
